08/31/88 Delta

Official Accident Report Index Page

Report Number	NTSB/AAR-89/04
Access Number	PB89-910406
Report Title	Delta Air Lines, Inc. Boeing 727-232, N473DA, Dallas-Fort Worth International Airport, Texas August 31, 1988
Report Date	September 26, 1989
Organization Name	National Transportation Safety Board Bureau of Accident Investigation Washington, D.C. 20594
WUN	4965A
Sponsor Name	NATIONAL TRANSPORTATION SAFETY BOARD Washington, D.C. 20594
Report Type	Highway Accident Report August 17, 1988
Distribution Status	This document is available to the public through the National Technical Information Service, Springfield, Virginia 22161
Report Class	UNCLASSIFIED
Pg Class	UNCLASSIFIED
Pages	135
Abstract	This report examines the crash of Delta flight 1141 while taking off at the Dallas-Forth Worth, Texas on August 31, 1988. The safety issues discussed in the report include flightcrew procedures; wake vortices; engine performance; airplane flaps and slats; takeoff warning system; cockpit discipline; aircraft rescue and firefighting; emergency evacuation; and survival factors. Recommendations addressing these issues were made to the Federal Aviation Administration, the American Asso

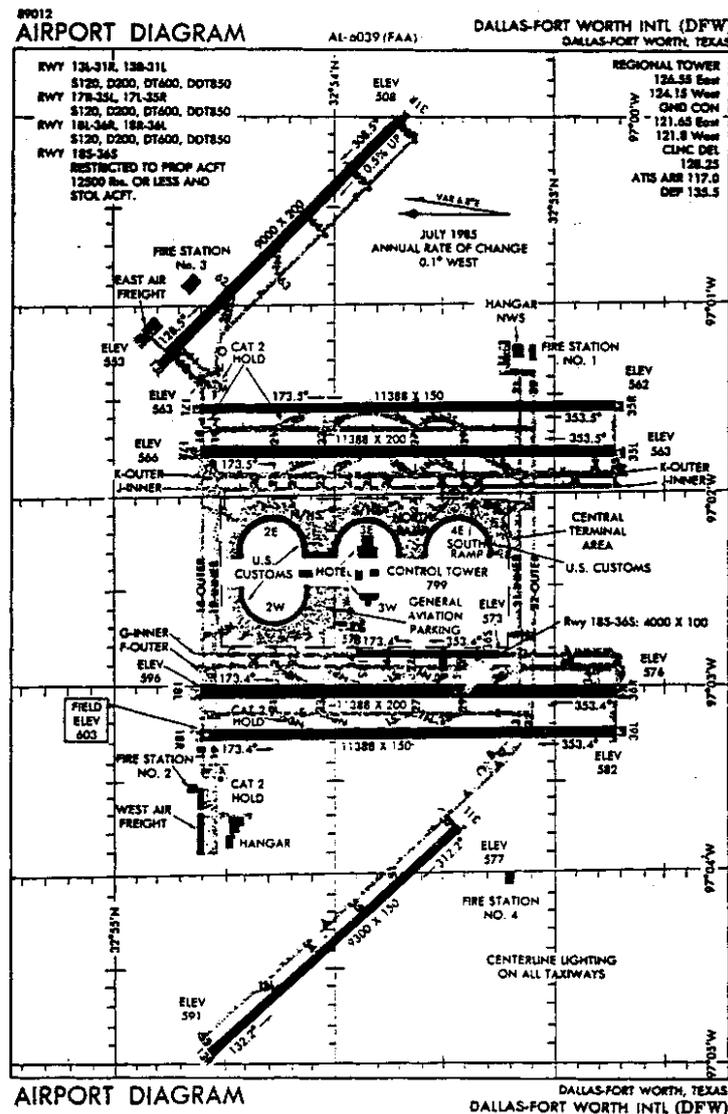
Figure 1.--Airport Diagram.

The last 600 feet of the wreckage track indicated that the remaining airplane structure slid sideways; most of the right wing structure outboard of the center fuel tank had disintegrated, until it came to rest near the airport boundary fence located approximately 3,200 feet from the departure end of runway 18L. ([See figure 1.](#))

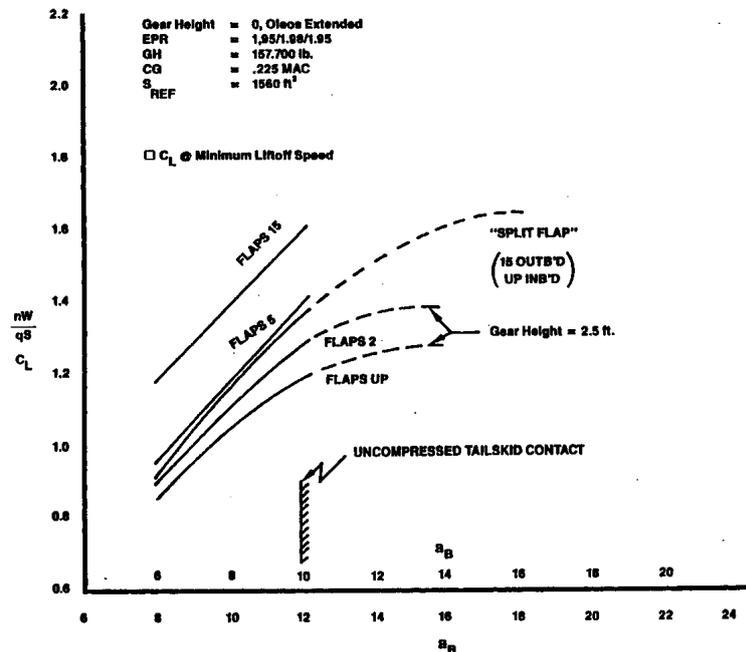
Figure 10.--Boeing 727 city curves, in ground effect zero altitude.

would be slightly less than with a normal flap setting of 5°. The stall AOA for "split flaps" is about 9° higher than the stall AOA for flaps at 15° or 5°. (See [figure 10](#) and [figure 11](#).) The "split flaps" scenario will be discussed later in this report.
